White Paper

PRESERVING CULTURAL COLLECTIONS THROUGH SUSTAINABLE PRACTICES

Sealaska Heritage Institute

Building designed and constructed to LEED Gold standards (Sustainability)

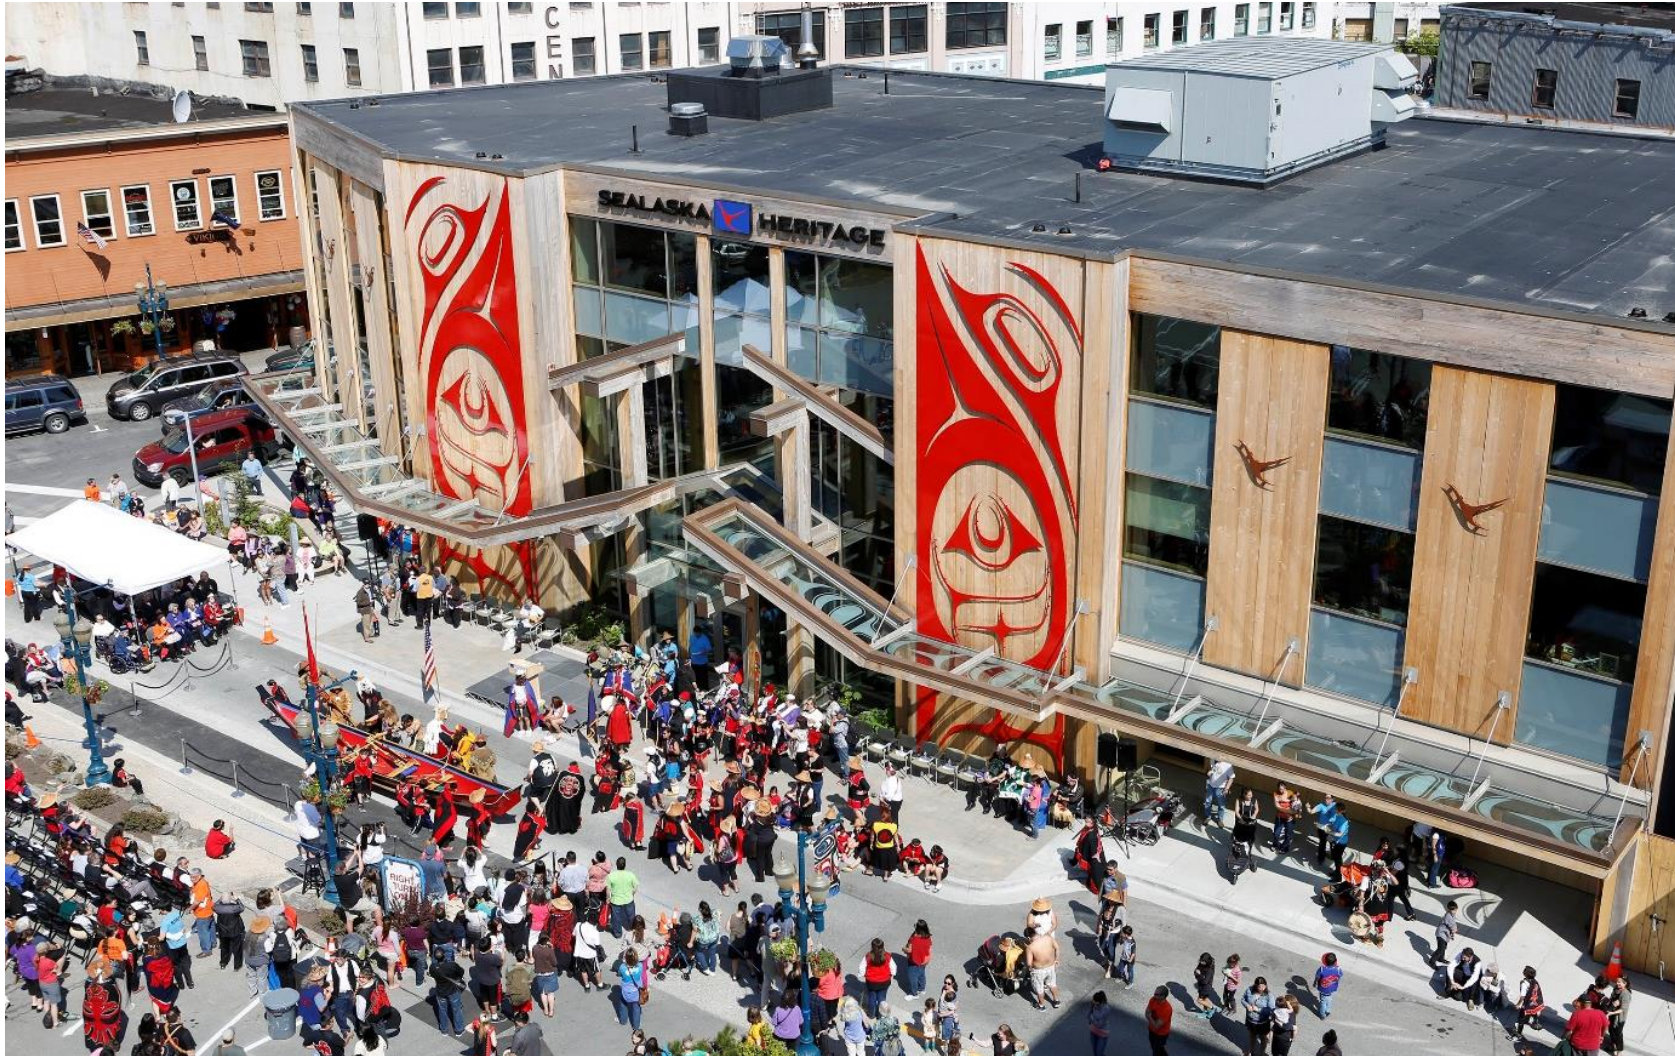
- Designed for energy conservation: wood pellet burner for heating, double intensity toilet flushing, low volume sink faucets
- Energy efficient building envelope: 18” insulation in roof, triple glaze windows, etc.
- Excess building materials were re-cycled or given away
- Comfortable and pleasing interior for occupants
- Certification in process (lengthy process)

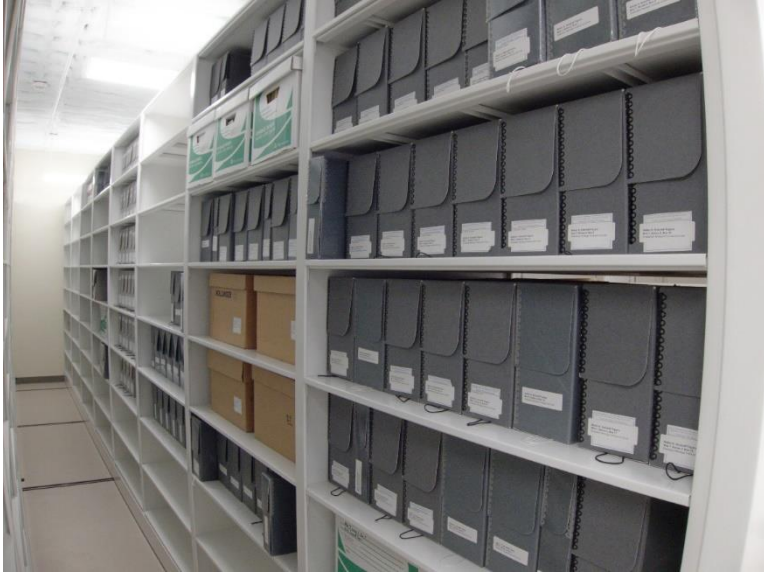
Archives

- Compact storage
 - 28.5' long x 8.15' high
- Shelves
 - 42" length x 11" high x 15.75" deep
 - 128 shelves per carriage
 - Hold up to 300 lbs
- One double-sided unit to allow for oversized items like maps and panoramic photographs

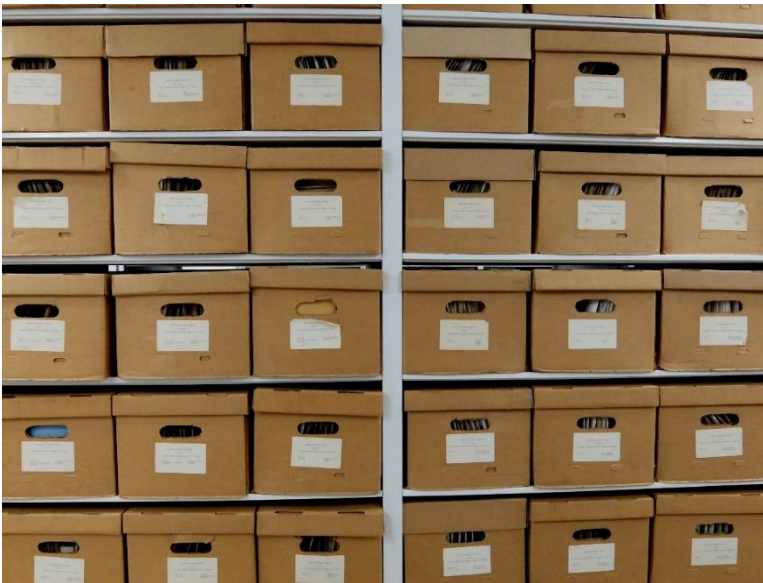
Library

- Compact storage
 - 28.5' long x 8.15' high
- Shelves
 - 2 23" wide x 15" high x 11" deep
 - 8 35.5" wide x 15" high x 11" deep
 - 140 shelves per carriage

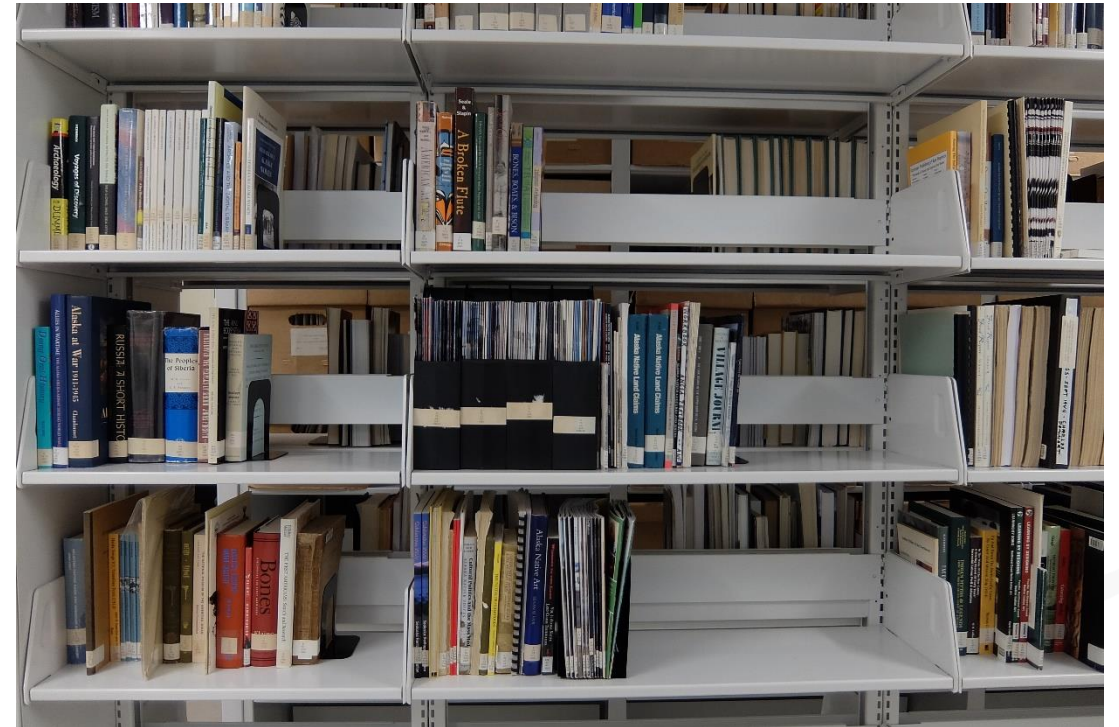
Issues

- Replaced 15" deep shelves with 11" deep shelves
- Center-stops vs backstops:
 - This was not discussed in initial order and became an issue later

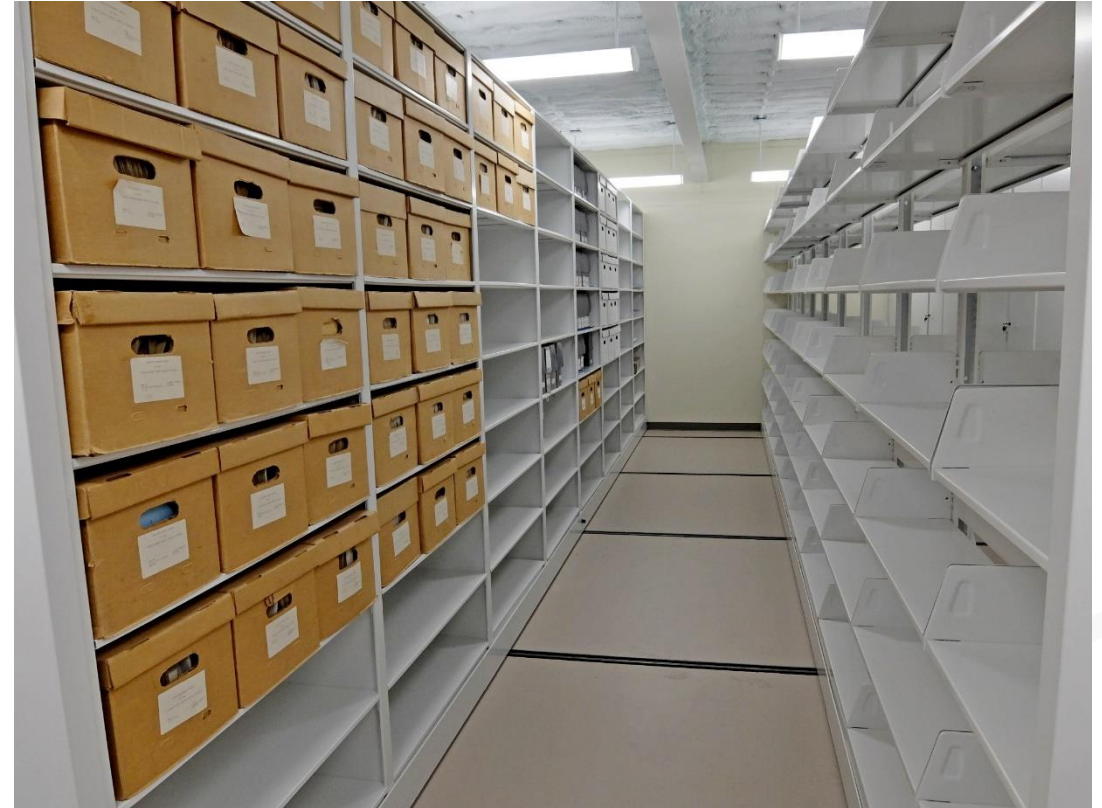
Ethnographic Objects

- Compact storage
 - 28.5' long x 8.15' high
- Drawers (sliding trays)
 - 1.75" high and spaced 2" apart vertically
- Shelves
 - 42" wide x 24" deep

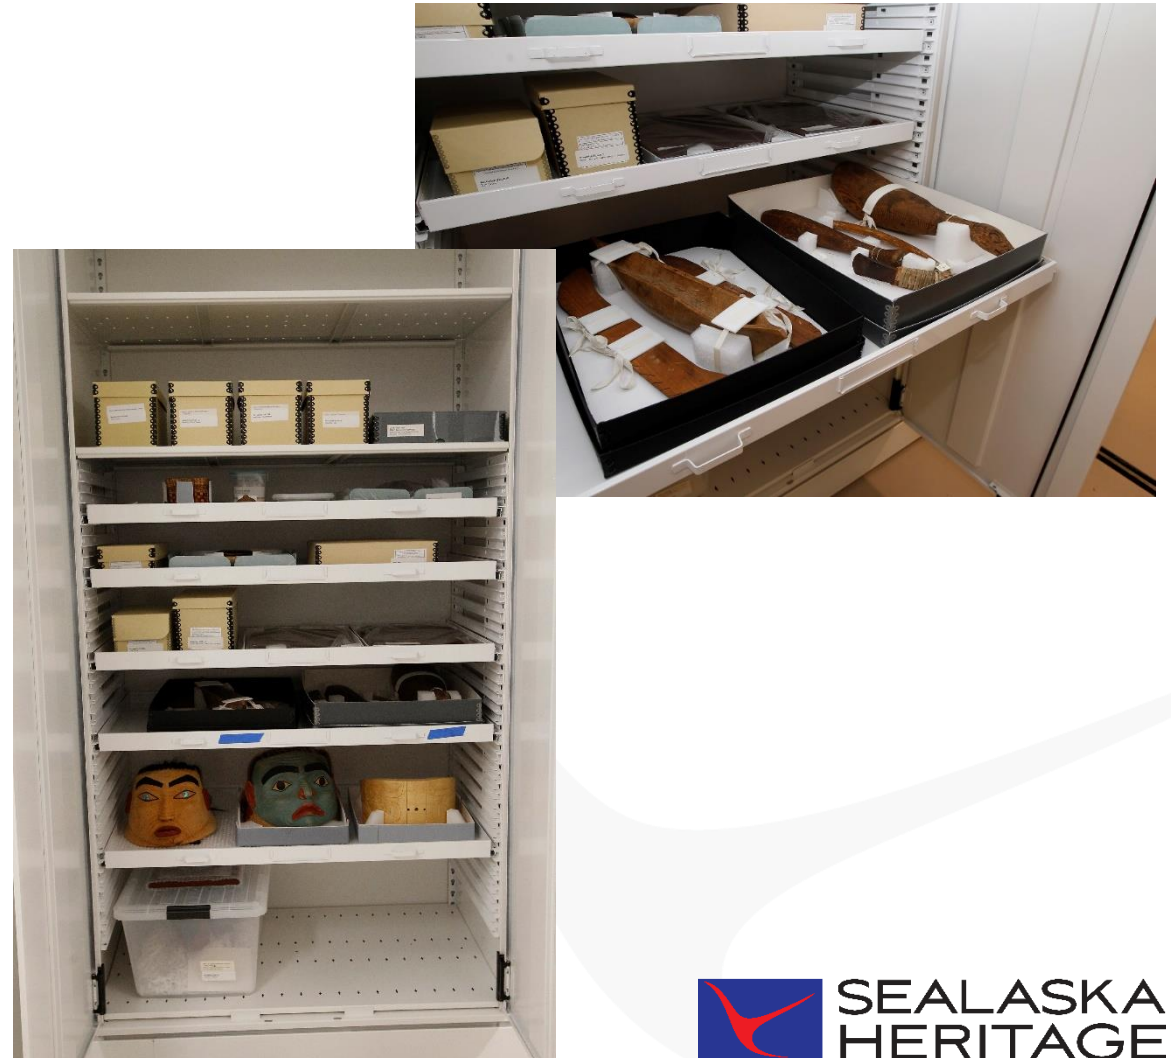
Issue

- Doors:
 - Tall and narrow
 - Flimsy
 - Did not fit together well
 - Fitted with strong magnets
- Solutions:
 - Spacers added to hinges
 - Removed magnets

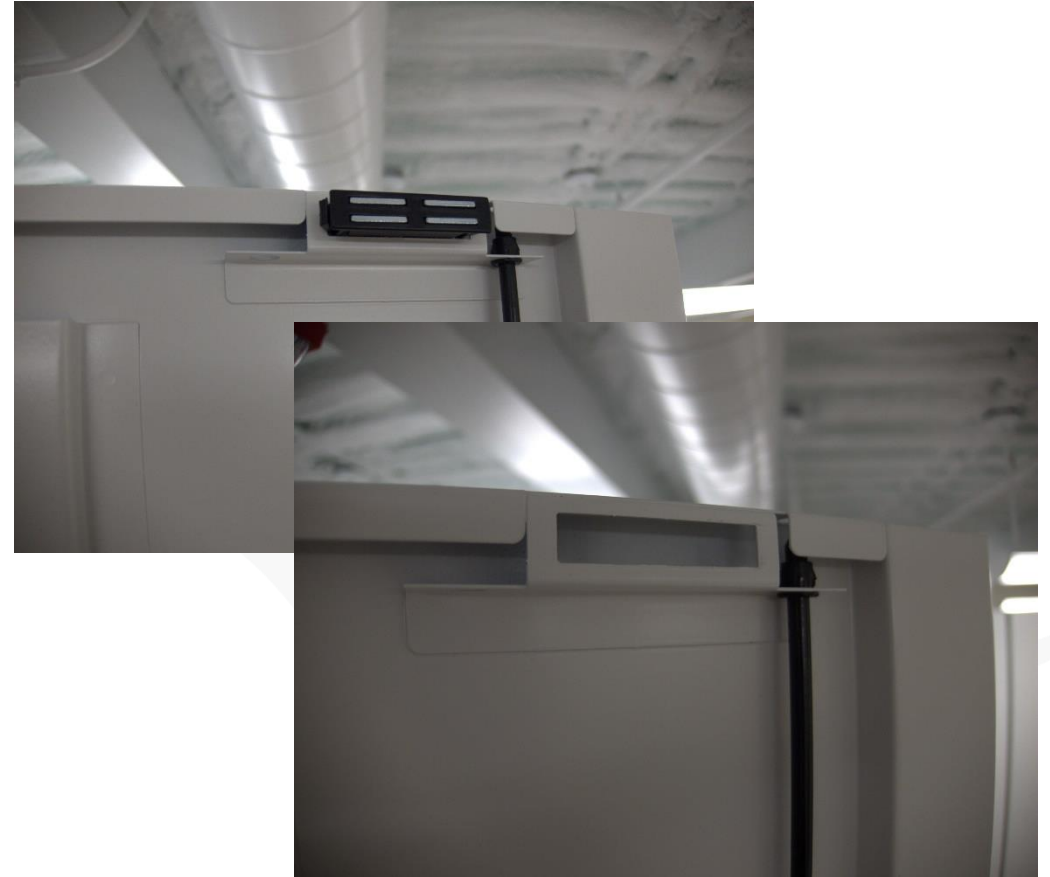
Issue

- Locks:
 - A different key for each cabinet
- Solution:
 - Change out locks so one key works on all locks in each row

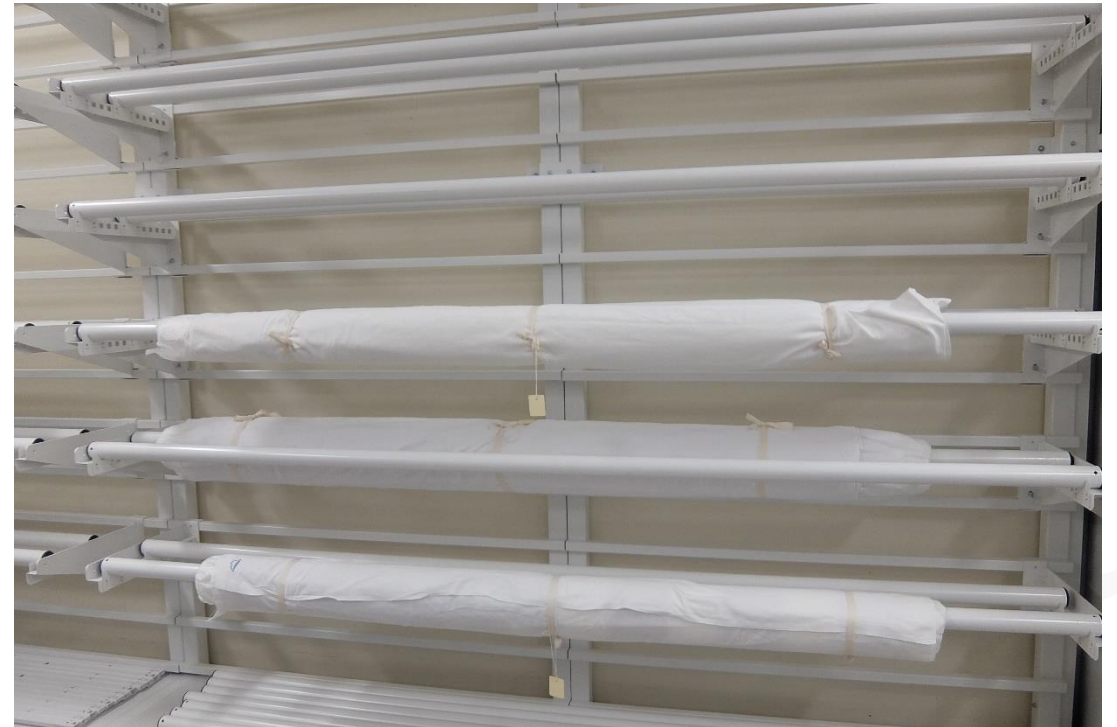
Issue

- Rollers:
 - Too long for racks
- Solution:
 - Cut rollers and reinstalled plastic end caps

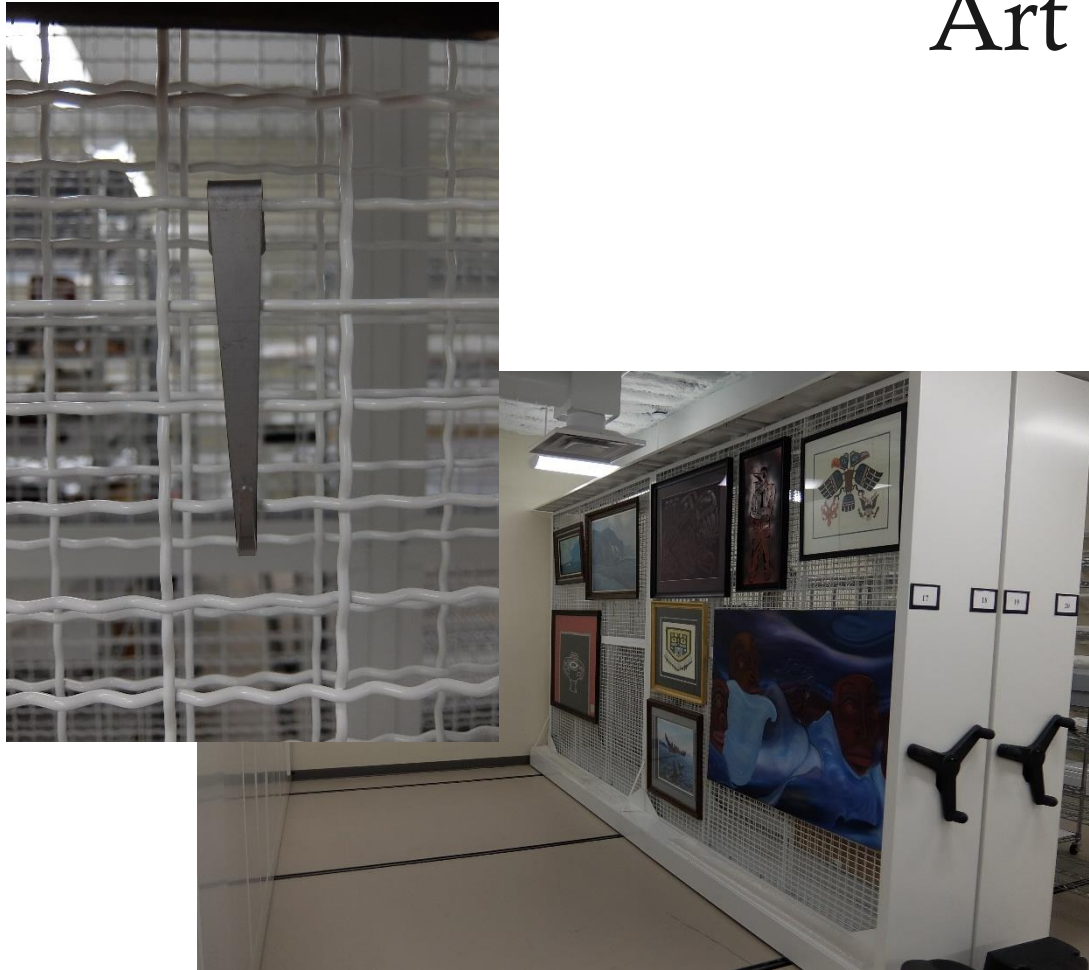
Art Racks

- Storage capacity:
 - 2 double-sided rows
 - 8.75' height x 15.85' width x 18.75" depth
- Accept "S" hook to allow storage of hanging artwork

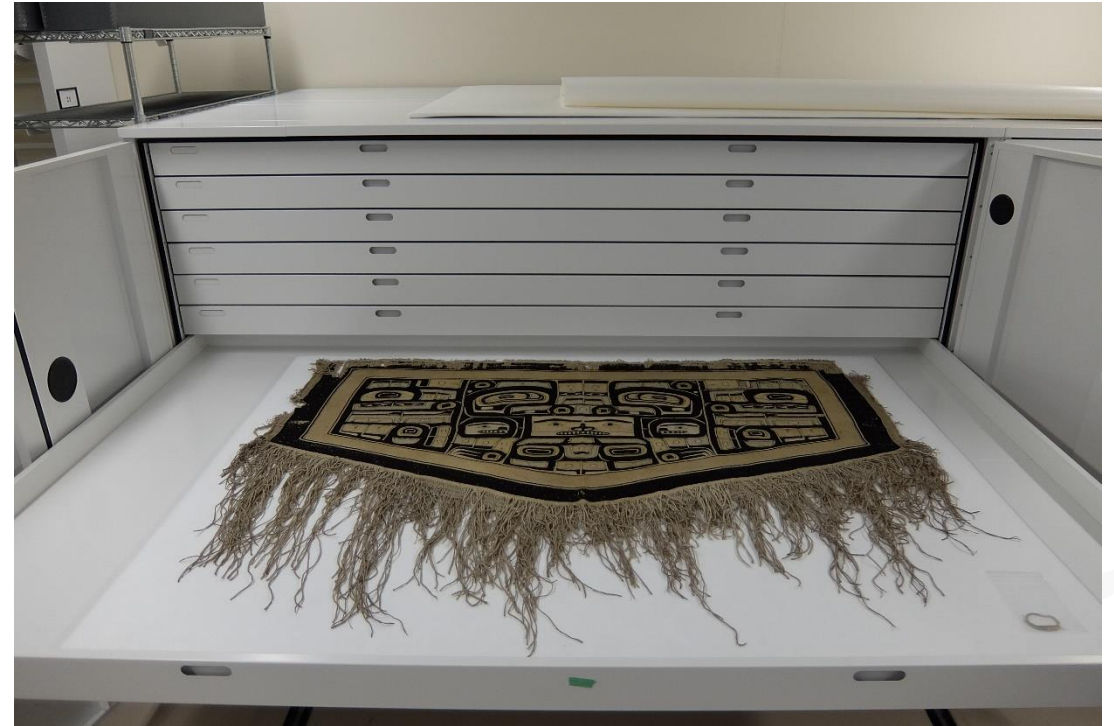
Textile Cabinets

- Delta Designs - Series 700
- Cabinet size
 - 8'2" wide x 5'4" deep x 5' high
 - 14 drawers
 - 6" adjustable base
- Custom drawer sizes
 - 60" deep x 90" wide x 3" high

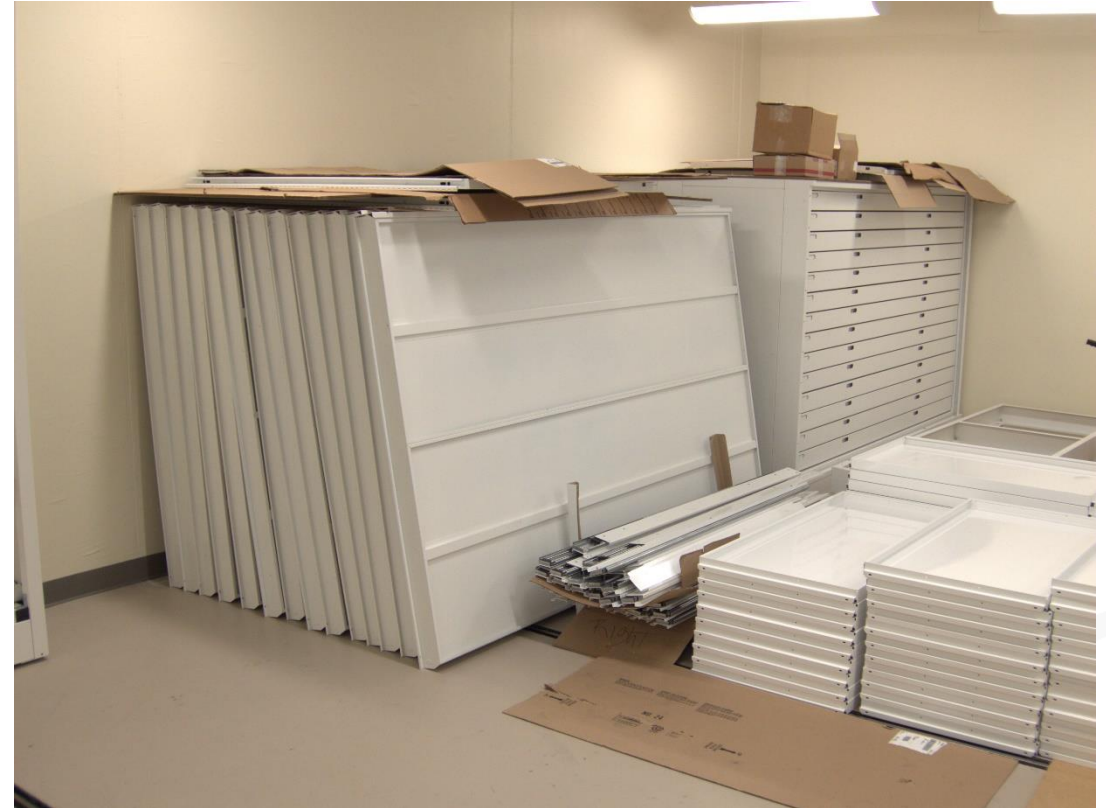
Issues

- Installation
 - External frame was not collapsible
 - Storage of parts
 - Elevator damage
- Solution
 - Reorder collapsible frame
 - No end solution for elevator

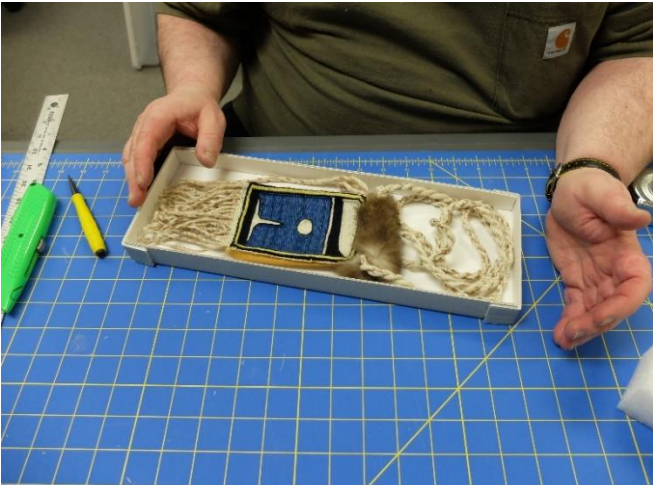
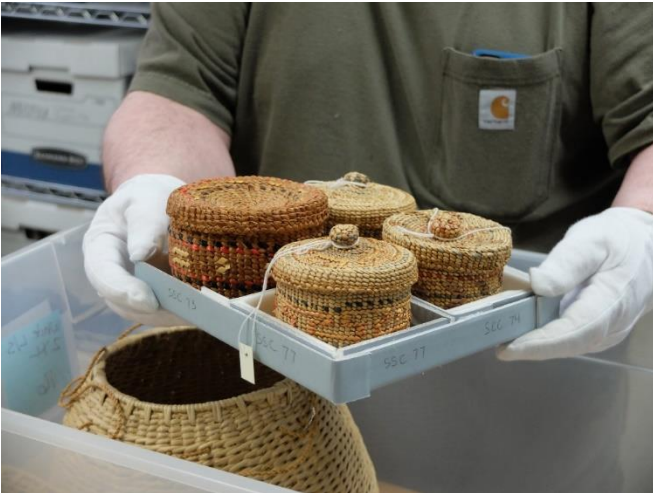
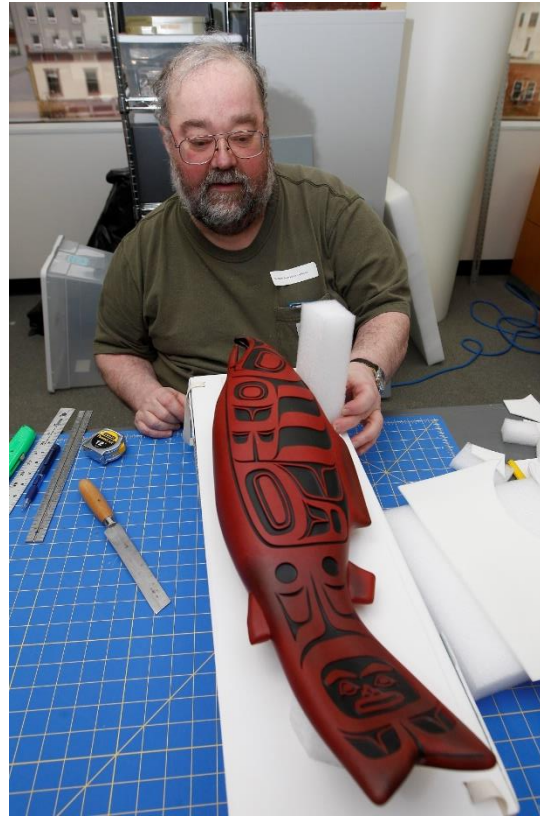
Storage Mounts for Sustainability

- Dual purpose mounts:
 - Protect the more sensitive objects from the rigors of moving
 - Serve as long term storage mounts in new location

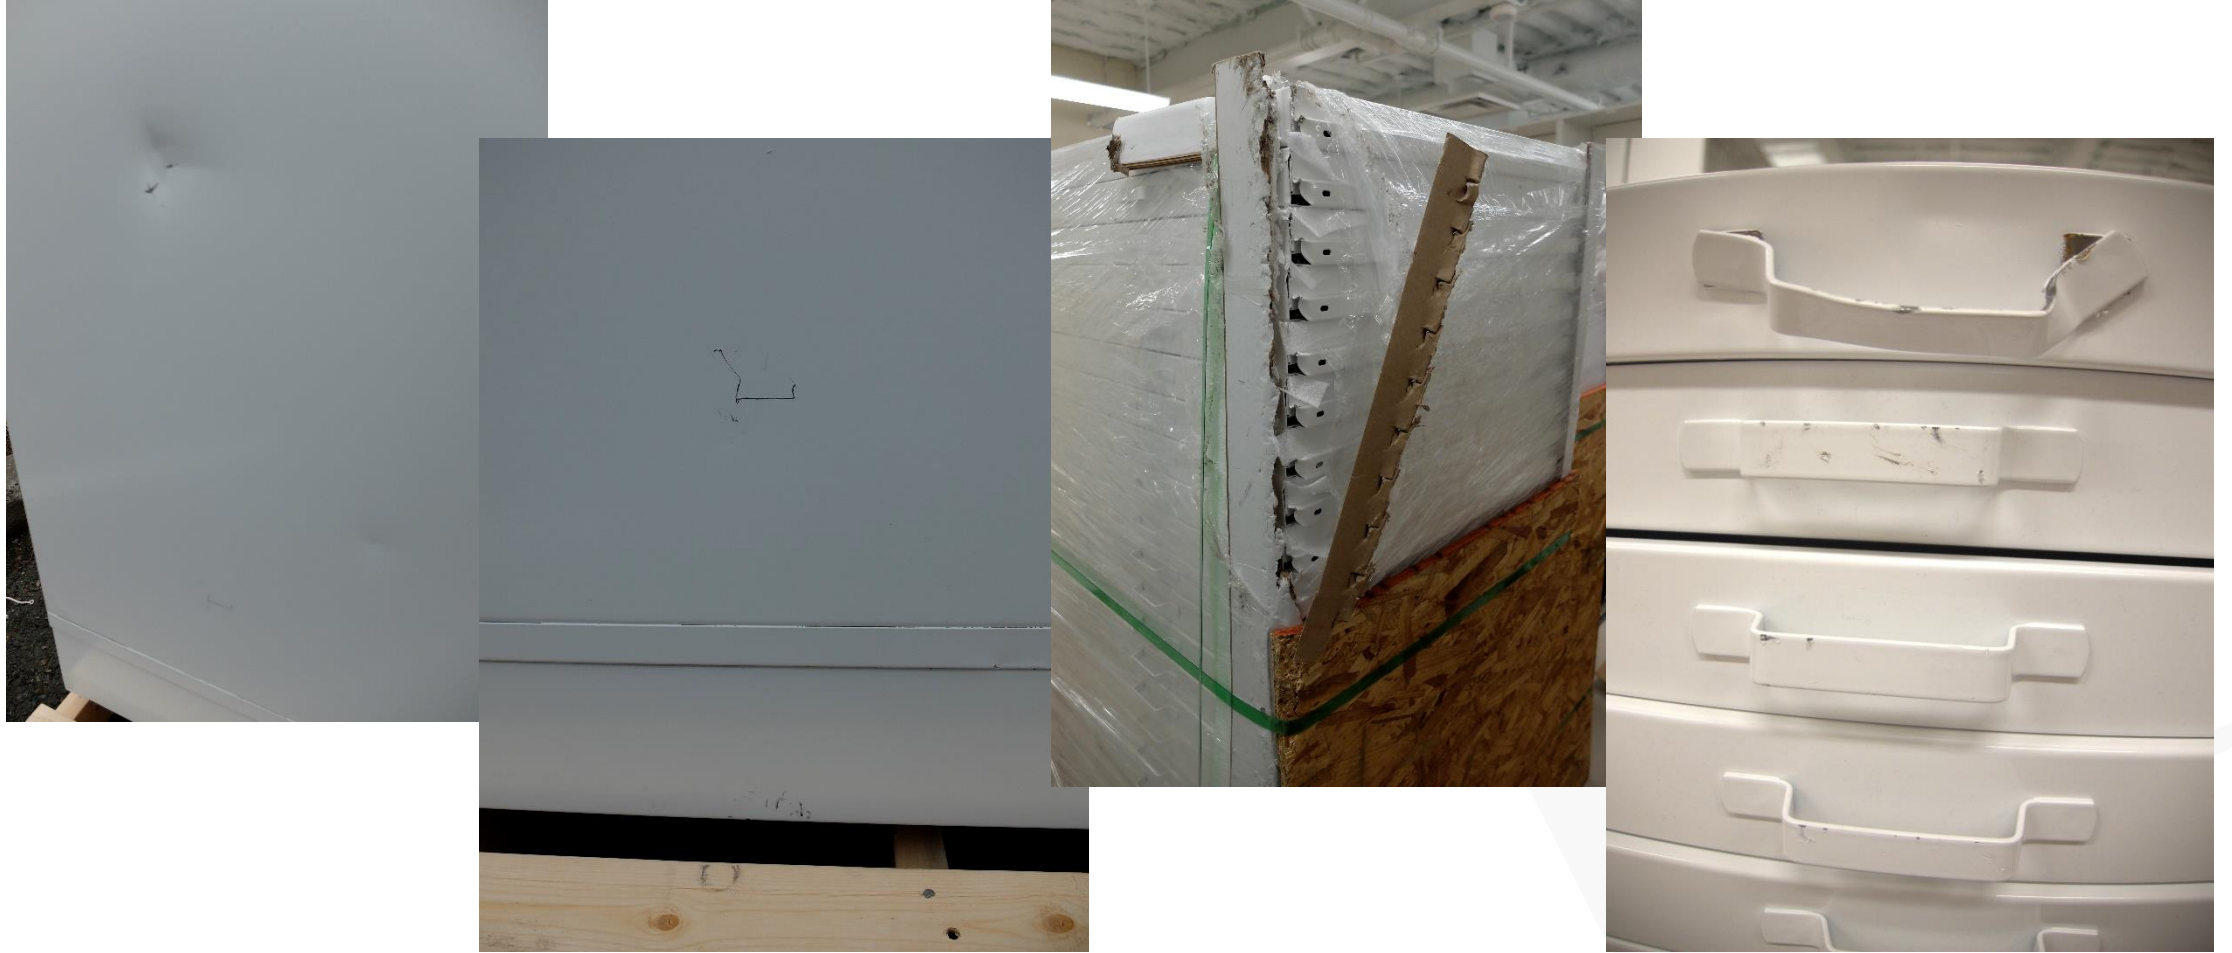
Installation Issue: Damaged Equipment

Three Types of Damage

1. Many items damaged in shipment: pull-out trays, tray brackets, dents on cabinet doors, dented/bent/warped archival shelves
2. Damages caused by installers
3. Problems in manufacturing: check for paint issues and poor fit
